ONTARIO WATER RESOURCES

WATER POLLUTION SURVEY

VILLAGE OF CAYUGA

APRIL - 1965

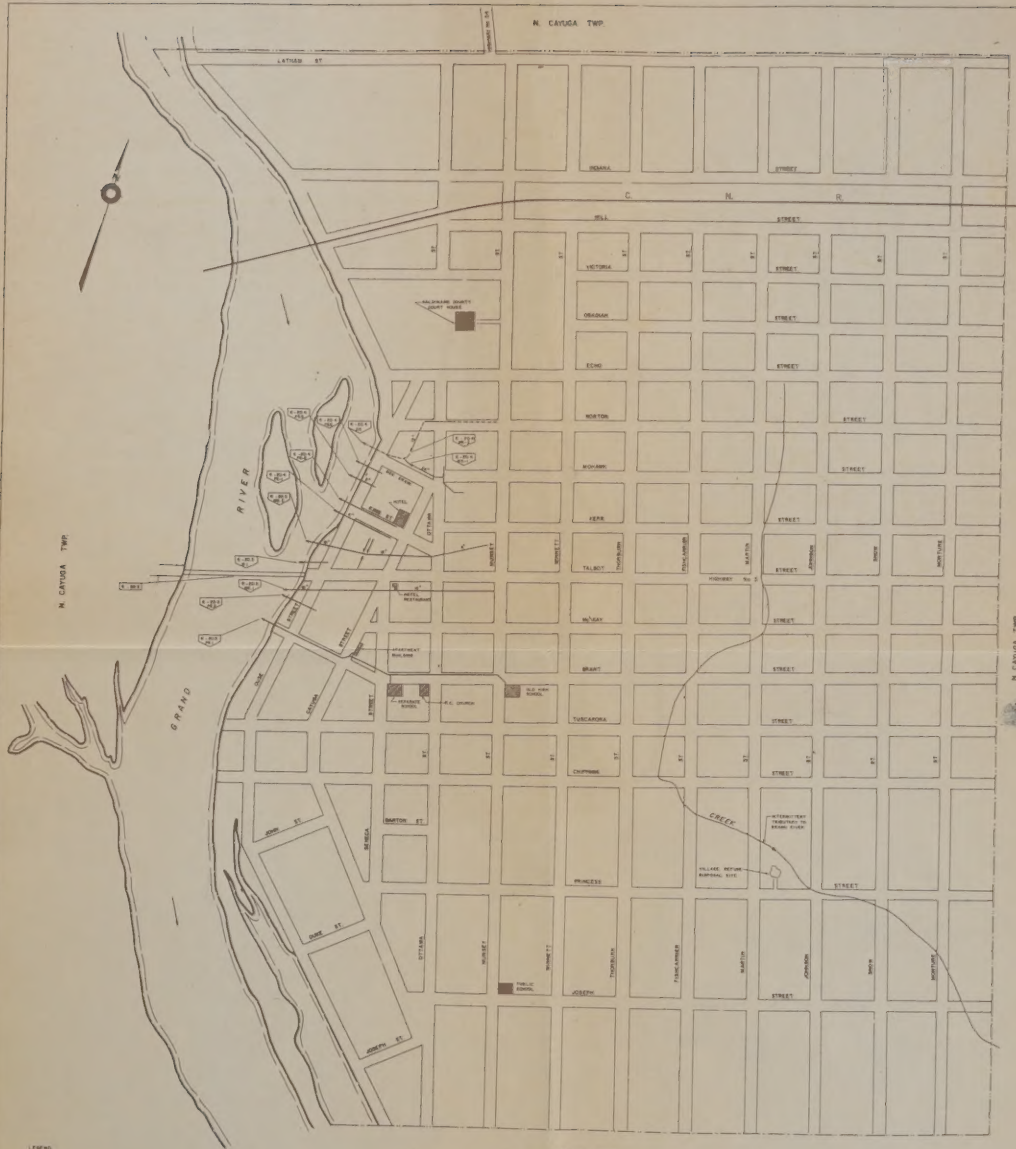
PLAN SHOWING OUTFALL LOCATIONS

Reference should be made to the appended plan of Cayuga for location of the sample points.

Sample results exhibit the fact that grossly contaminated wastewater was being discharged to the Grand River from five outfalls. Four other outfalls along the river bank were not sampled due to insufficient flow, but sewage solids were observed in the vicinity of the outlets.

It is recommended that the Village of Cayuga proceed with the installation of sanitary sewers and a sewage treatment system.
